Manhole Inspection Summary

Manhole # S13QQ1003MH

Insp Date: **11/2/06 9:00 AM**

Location Address: **2700 CYLBURN AVE**

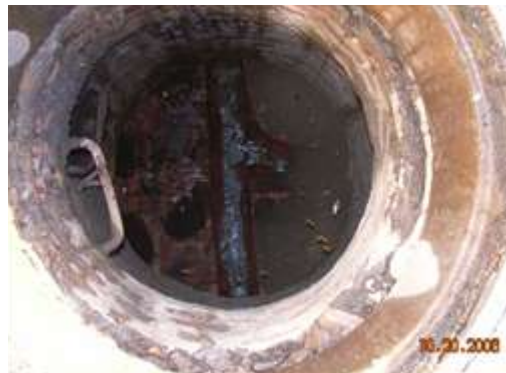
Top View

Frame leaks. Frame offset. Adjustment deterioration and infiltration. Evidence of surcharge - Bench debris. Channel

Defect

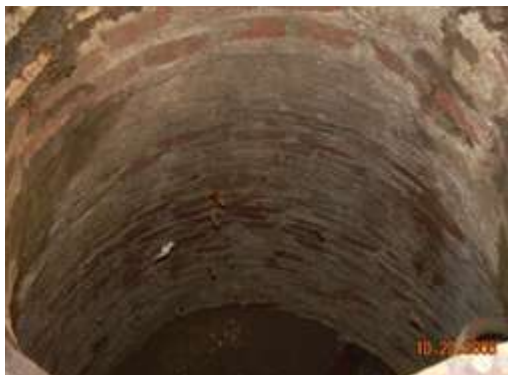
Adjustment and Corbel infiltration.

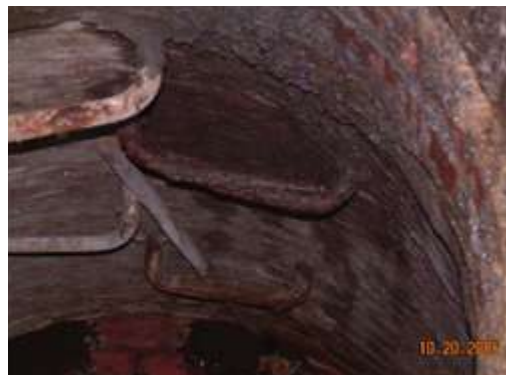
Frame leaks. Adjustment and Corbel infiltration. Corroded steps.

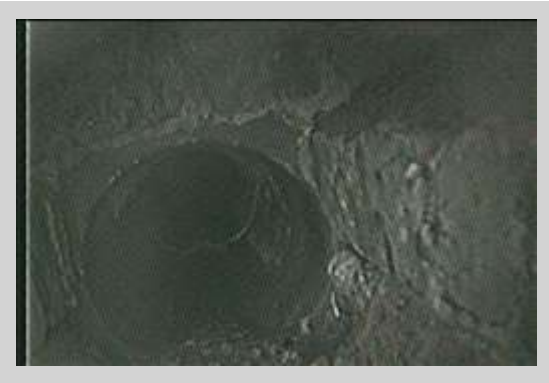
8 in. Circular Gravity Sewer Pipe Out @ 12 O'Clock

Infiltration: **Evidence** Pipe Seal Cond: **Cracked**

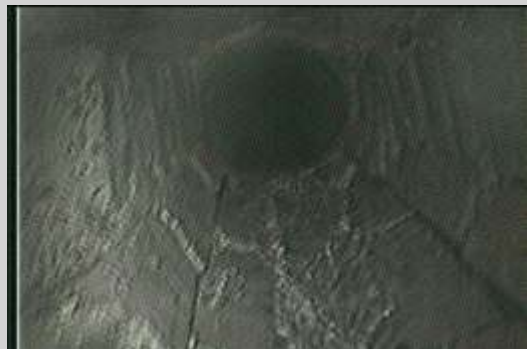
Pipe In @ 6 O'Clock

Channel deterioration.
